PLAYGROUND SAFETY IN GALVESTON PARKS: A DESCRIPTIVE ANALYSIS

Capstone

December 2007

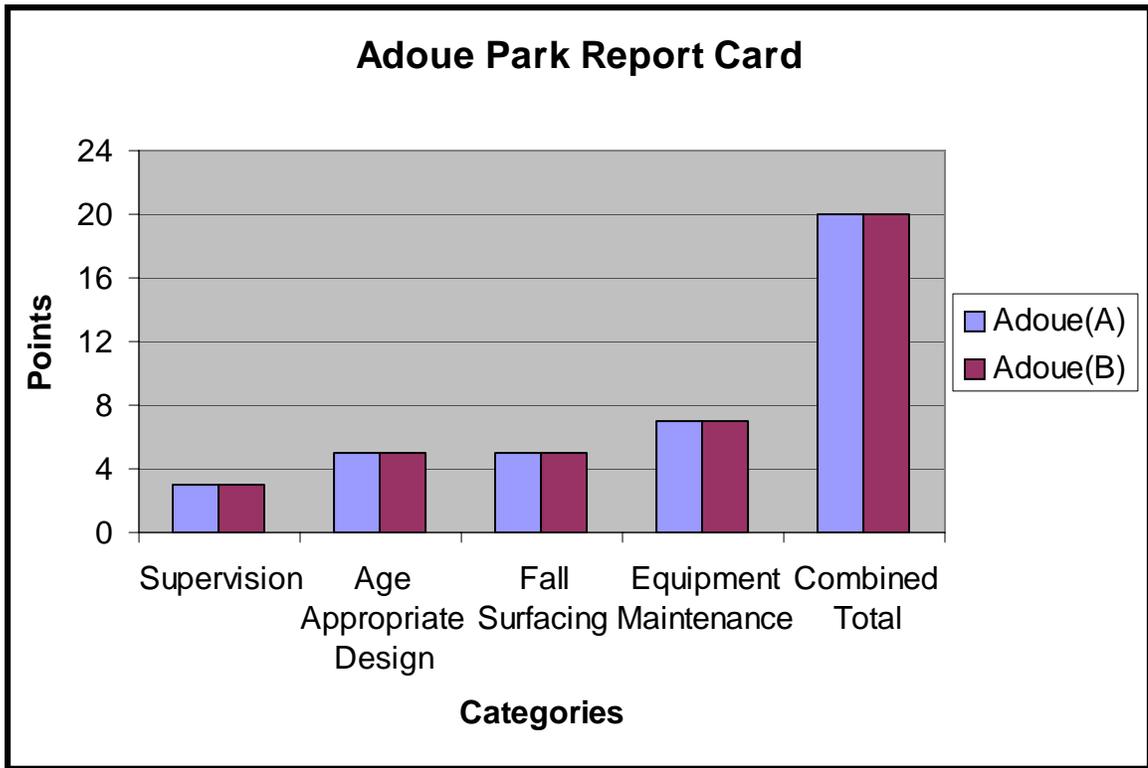
Figure 1: Adoue Park Safety Report Card Scoring

Figure 1 depicts the NPPS safety report card scoring on the survey of Adoue Park. The park was surveyed on April 18, 2007. This park has two composite structure areas. Adoue(A) lost one of four points under the supervision category for lack of signs posted regarding behavior. One out of six points was lost under the age-appropriate design category for lack of signs indicating appropriate age for use. One out of six points was lost under the fall surfacing category for a critical height over eight feet. One point out of eight points was lost secondary to rust under the equipment maintenance category. Adoue(B) scored the same demerits except in the fall surfacing category where it lost one point of six points for inappropriate loose fill depth at 7.5 inches (8 inches required) of wood chips. Overall, Adoue Park scored 20/24 points for an “A” grade.

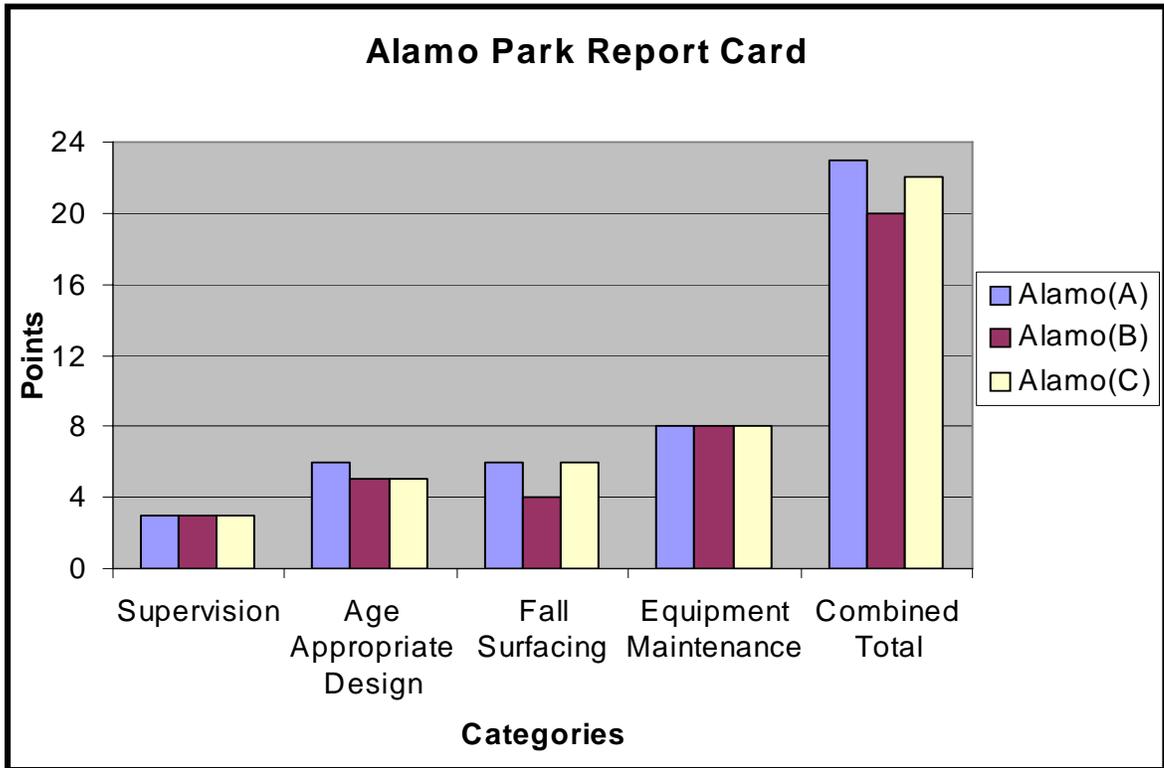
Figure 3: Alamo Park Safety Report Card Scoring

Figure 3 illustrates the NPPS safety report card scoring on the survey of Alamo Park. The park was surveyed on April 20, 2007. This park has three composite structure areas. All Alamo structures lost one of four points under the supervision category for lack of signs posted regarding behavior. One out of six points was lost under the age-appropriate design category for lack of signs for age, except for Alamo(A). One out of six points was lost under the fall surfacing category for a critical height over eight feet for Alamo(B). No deficits were noted in the equipment maintenance category for Alamo Park. Overall, Alamo Park scored 22/24 points for an “A” grade.

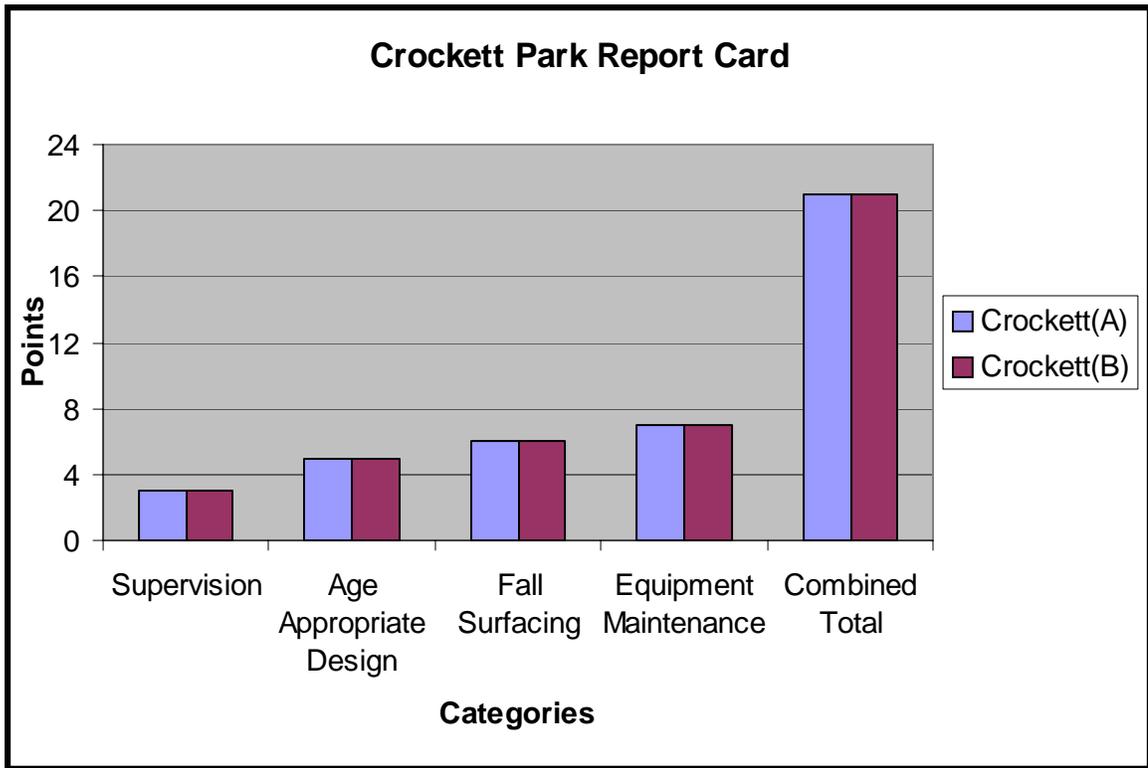
Figure 5: Crockett Park Safety Report Card Scoring

Figure 5 shows the NPPS safety report card scoring on the survey of Crockett Park on April 19, 2007. This park has two composite structure areas. All Crockett park structures lost one of four points under the supervision category for lack of signs posted regarding behavior. Both structures lost one out of six points under the age-appropriate design category for lack of signs for age. No deficits were noted in the falls surfacing category for Crockett Park. Crockett(A) lost a point for rust in the equipment maintenance category. Overall, Crockett Park scored 21/24 points for an “A” grade.

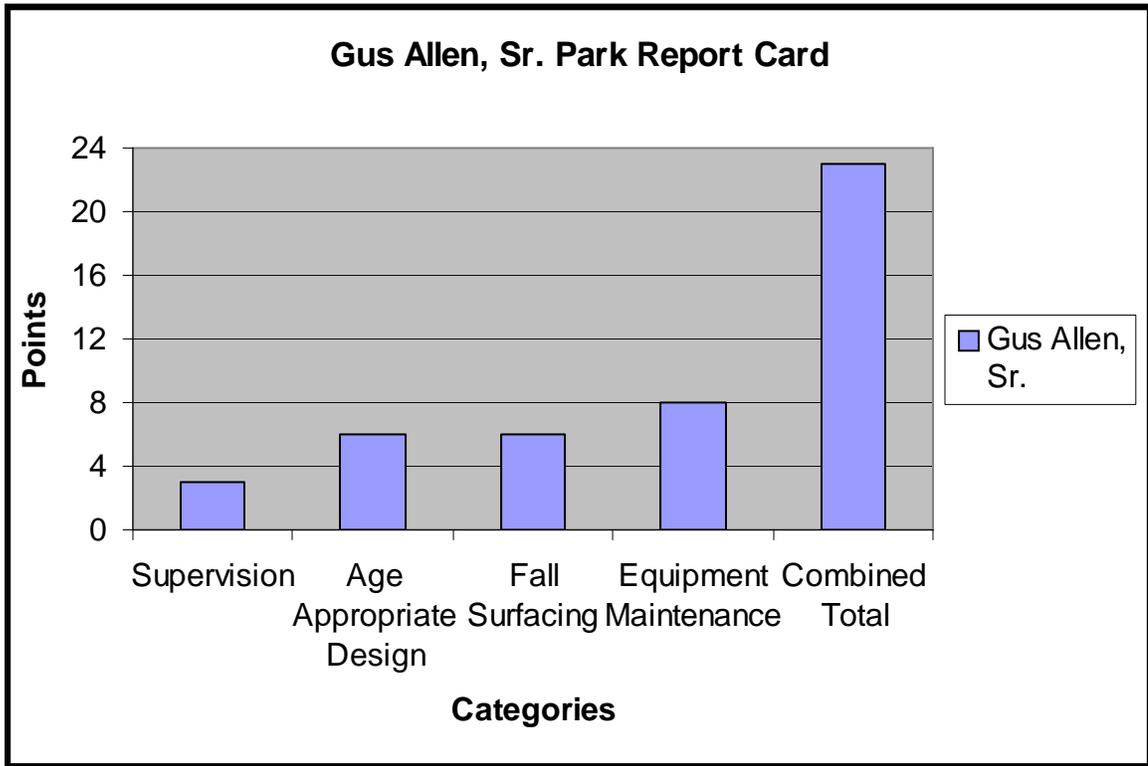
Figure 7: Gus Allen, Sr. Park Safety Report Card Scoring

Figure 7 shows the NPPS safety report card scoring on the survey of Gus Allen, Sr. Park on April 19, 2007. This park has only one composite structure area. Gus Allen, Sr. Park lost only one point under the supervision category for lack of signs posted regarding behavior. No other deficits were noted. Overall, Gus Allen, Sr. Park scored 23/24 points for an “A” grade.

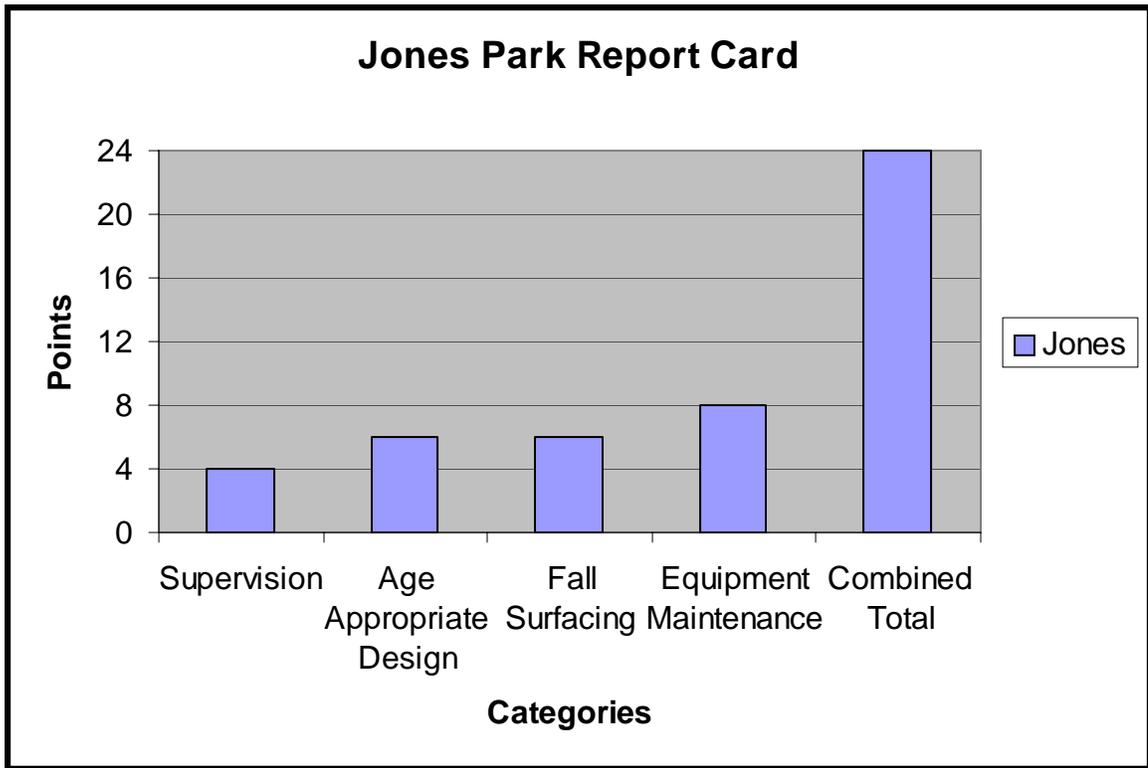
Figure 9: Jones Park Safety Report Card Scoring

Figure 9 represents the NPPS safety report card scoring on the survey of Jones Park on April 20, 2007. This park has one composite structure area. Jones Park scored a perfect score without any deficits on evaluation. Overall, Jones Park scored 24/24 points for an “A+” grade.

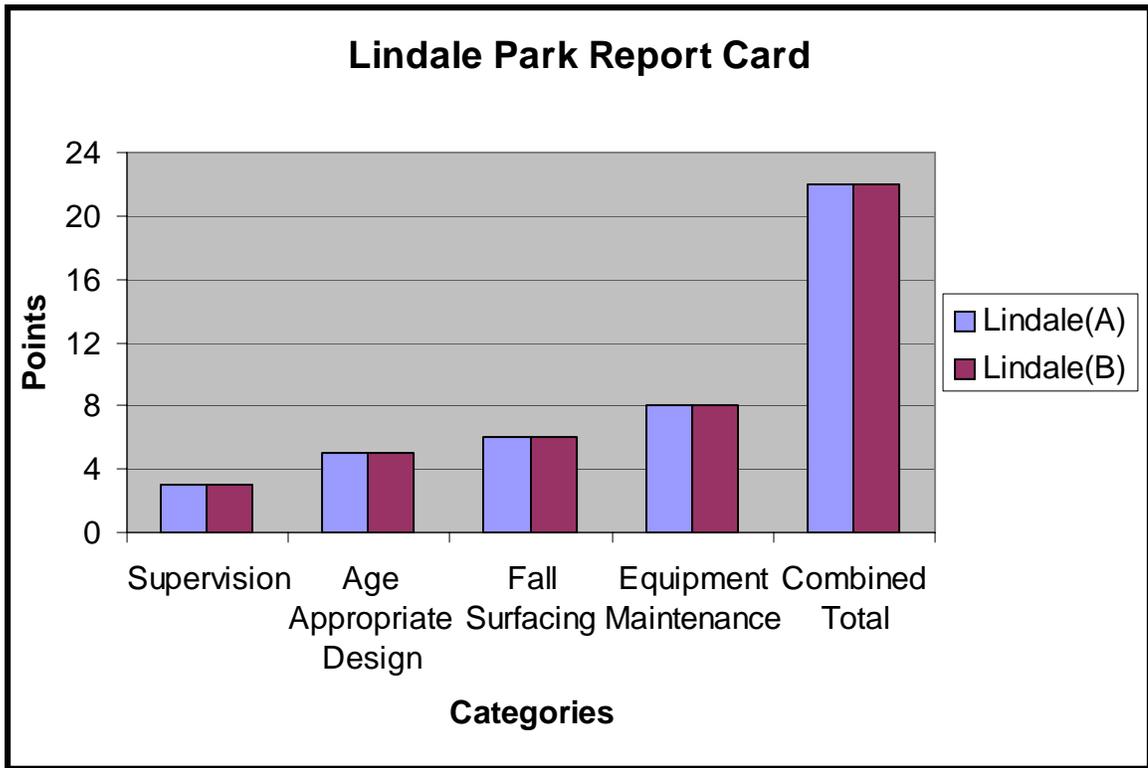
Figure 11: Lindale Park Safety Report Card Scoring

Figure 11 displays the NPPS safety report card scoring on the survey of Lindale Park on April 10, 2007. This park has two composite structure areas. All Lindale park structures lost one point under the supervision category for lack of signs posted regarding behavior. Both structures lost one out of six points under the age-appropriate design category for lack of signs for age. No deficits were noted in the falls surfacing or equipment maintenance categories for Lindale Park. Overall, Lindale Park scored 22/24 points for an “A” grade.

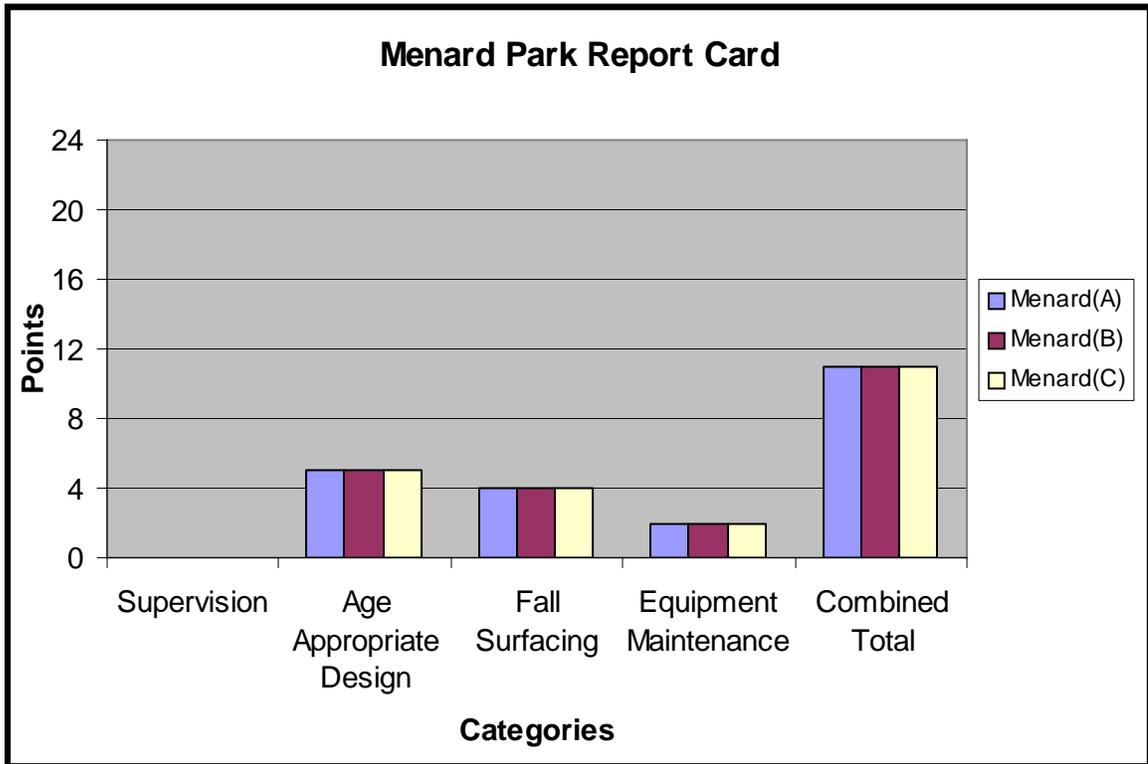
Figure 13: Menard Park Safety Report Card Scoring

Figure 13 demonstrates the NPPS safety report card scoring on the survey of Menard Park on April 19, 2007. This park has three composite structure areas. Menard Park is currently closed and fenced off for renovation, so only visual data could be obtained. Three of the four items in the supervision category, two of six items in the fall surfacing category, and six of the eight items in the equipment maintenance category could not be evaluated. A full survey could not be accomplished secondary to these restraints. All Menard park structures lost one of four points under the supervision category for lack of signs posted regarding behavior. All structures lost one out of six points under the age-appropriate design category for lack of signs for age. No other deficits were noted on limited exam in the falls surfacing and equipment maintenance categories. Overall, Menard Park scored 11/14 points, but could not complete overall scoring.

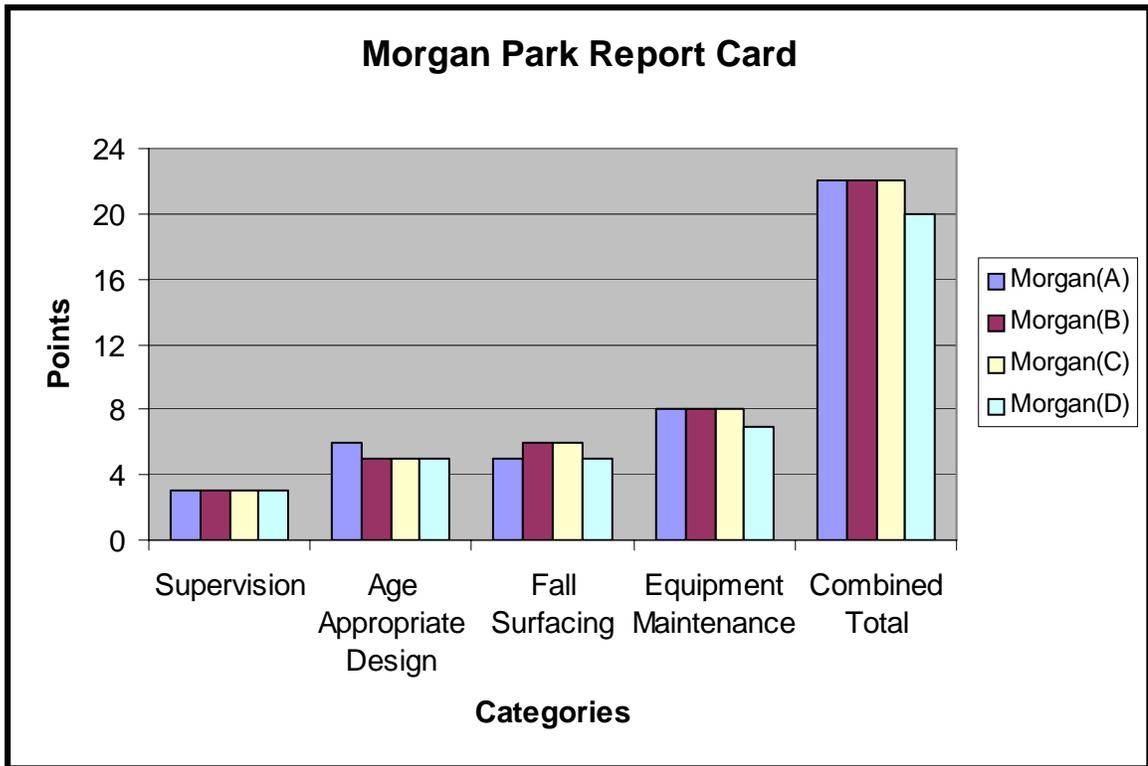
Figure 15: Morgan Park Safety Report Card Scoring

Figure 15 displays the NPPS safety report card scoring on the survey of Morgan Park on April 20, 2007. This park has four composite structure areas. All Morgan park structures lost a point under the supervision category for lack of signs posted regarding behavior. All structures, except Morgan(A) lost a point under the age-appropriate design category for lack of signs for age. Morgan(D) lost a point for lack of six-foot use zone in the falls surfacing category. Morgan(D) lost a point for rust in the equipment maintenance category. Overall, Morgan Park scored 22/24 points for an “A” grade.

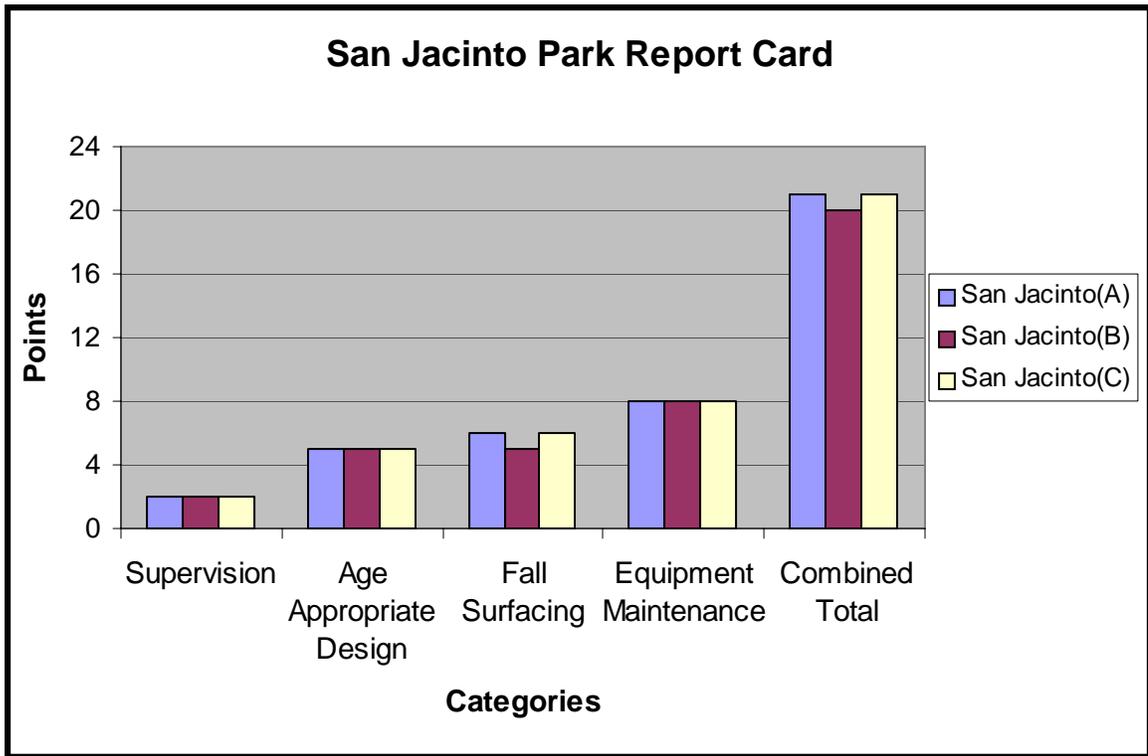
Figure 17: San Jacinto Park Safety Report Card Scoring

Figure 17 represents the NPPS safety report card scoring on the survey of San Jacinto Park on April 19, 2007. This park has three composite structure areas. All San Jacinto park structures lost two points under the supervision category for lack of signs posted regarding behavior and lack of adult supervision. All structures lost a point under the age-appropriate design category for lack of signs for age. San Jacinto(B) lost a point for critical height violation in the fall surfacing category. No deficits were noted in the equipment maintenance category for San Jacinto Park. Overall, San Jacinto Park scored 21/24 points for an “A” grade.

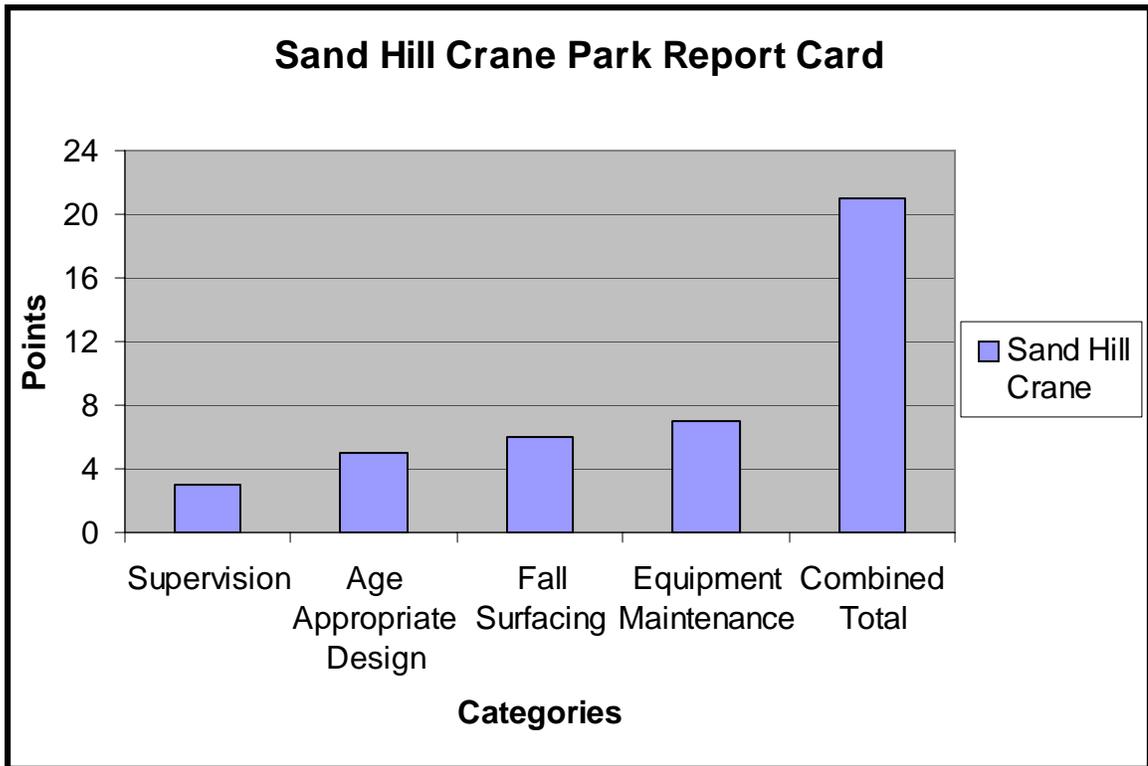
Figure 19: Sand Hill Crane Park Safety Report Card Scoring

Figure 19 illustrates the NPPS safety report card scoring on the survey of Sand Hill Crane Park on April 20, 2007. This park has only one composite structure area. Sand Hill Crane park structures lost a point under the supervision category for lack of signs posted regarding behavior. Sand Hill Crane Park also lost a point under the age-appropriate design category for lack of signs for age. No deficits were noted in the falls surfacing category. The park lost a point for rust in the equipment maintenance category. Overall, Sand Hill Crane Park scored 21/24 points for an “A” grade.

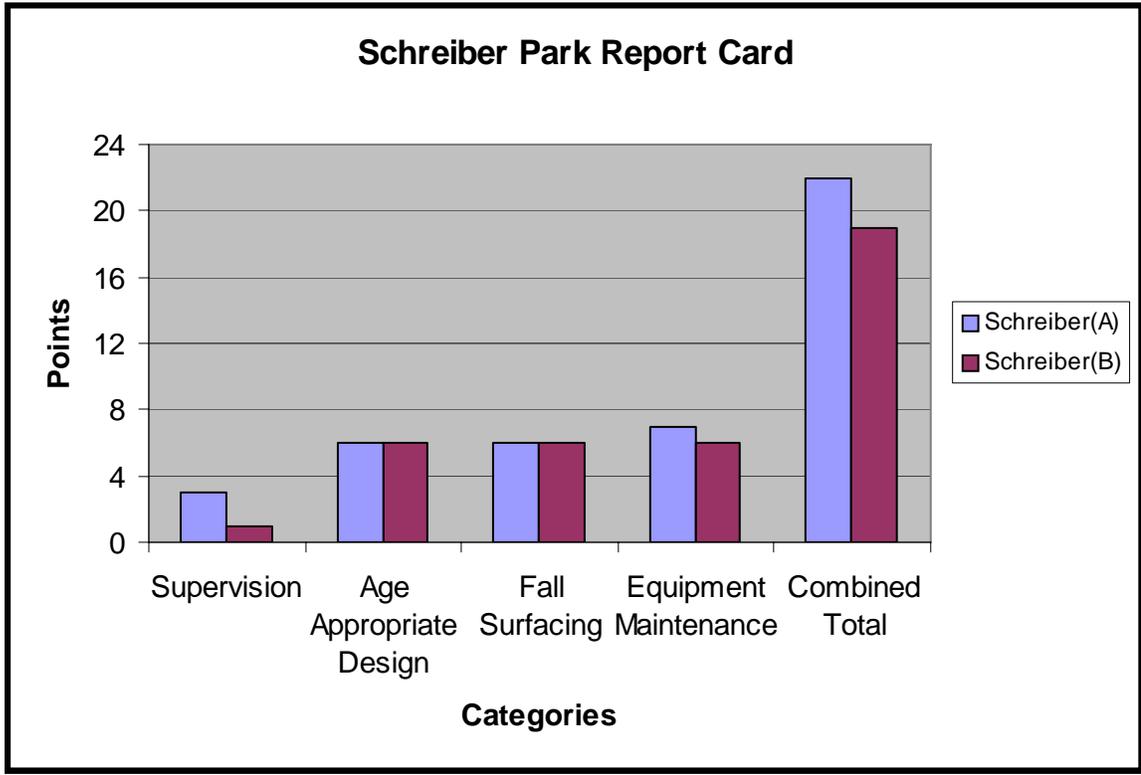
Figure 21: Schreiber Park Safety Report Card Scoring

Figure 21 displays the NPPS safety report card scoring on the survey of Schreiber Park on April 20, 2007. This park has two composite structure areas and is the only entire wood-based playground. Both park structures lost one of four points under the supervision category for lack of signs posted regarding behavior and Schreiber(B) also lost a point for visualization of crawl spaces. No deficits were noted in the age-appropriate design or falls categories. Both structure lost a point for rust and Schreiber(B) also lost a point for a protruding bolt in the equipment maintenance category. Overall, Schreiber Park also scored 21/24 points for a grade of “A”.

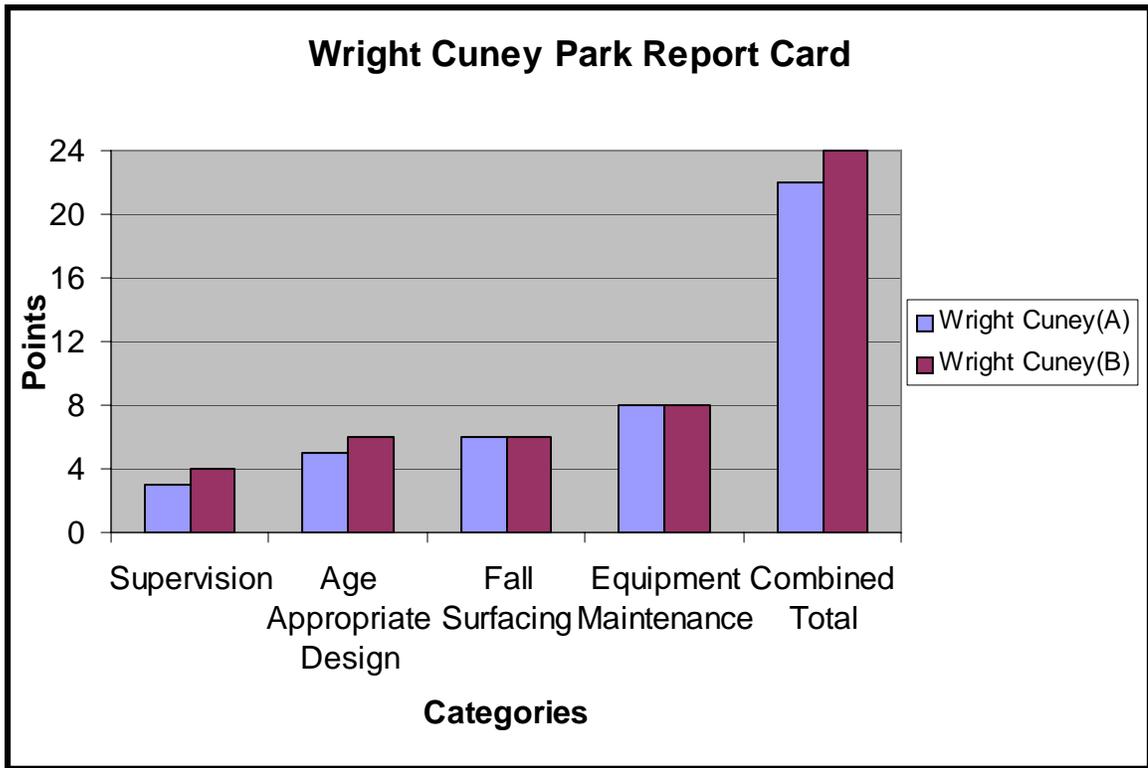
Figure 23: Wright Cuney Park Safety Report Card Scoring

Figure 23 depicts the NPPS safety report card scoring on the survey of Wright Cuney Park on April 20, 2007. This park has two composite structure areas and is the central office for the Galveston Parks and Recreation office. Wright Cuney(A) lost one point under the supervision category for lack of signs posted regarding behavior. Wright Cuney(A) lost another point under the age-appropriate design category for lack of signs for age. No deficits were noted in the falls surfacing or equipment maintenance categories for Wright Cuney Park. Overall, Wright Cuney Park scored 23/24 points for a grade of “A”.

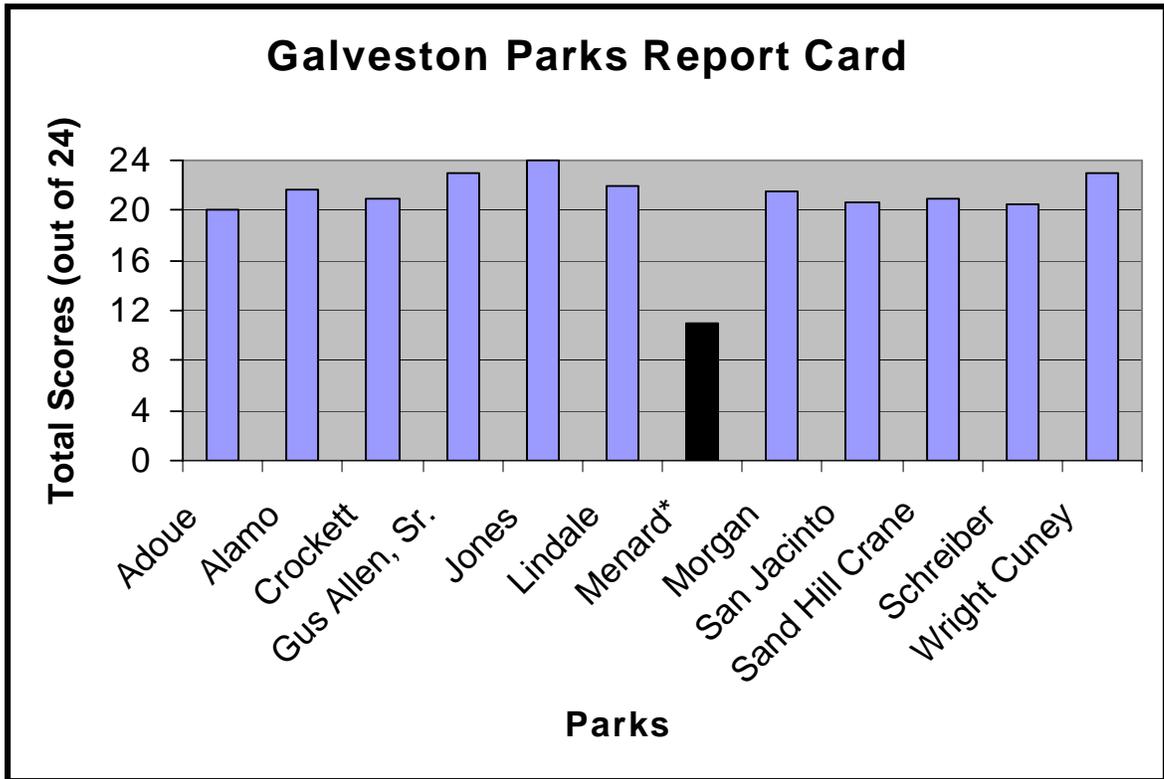
Figure 25: Galveston Parks Safety Report Card Scoring

Figure 25 summarizes the scoring of the Galveston park playground areas according to the NPPS scoring system. The NPPS scoring system states that a combined overall score of 20 or higher is an “A”. All the blue lines represent a score of “A” for the park. The black line and asterisk for Menard Park are to denote that an incomplete survey was done because the park was closed for renovations. No score could be assigned for that reason. All open Galveston parks scored extremely well on the NPPS scoring system. Most points were lost on lack of signs to explain appropriate behavior and rules of the playground and what ages are appropriate to play on the playground equipment to prevent injury. Rust was also another common theme under the equipment maintenance category.
