Memorandum

10 JULY 1968
EC9618/1576

SUBJECT: Cable short circuit in spacecraft 101 C²F²

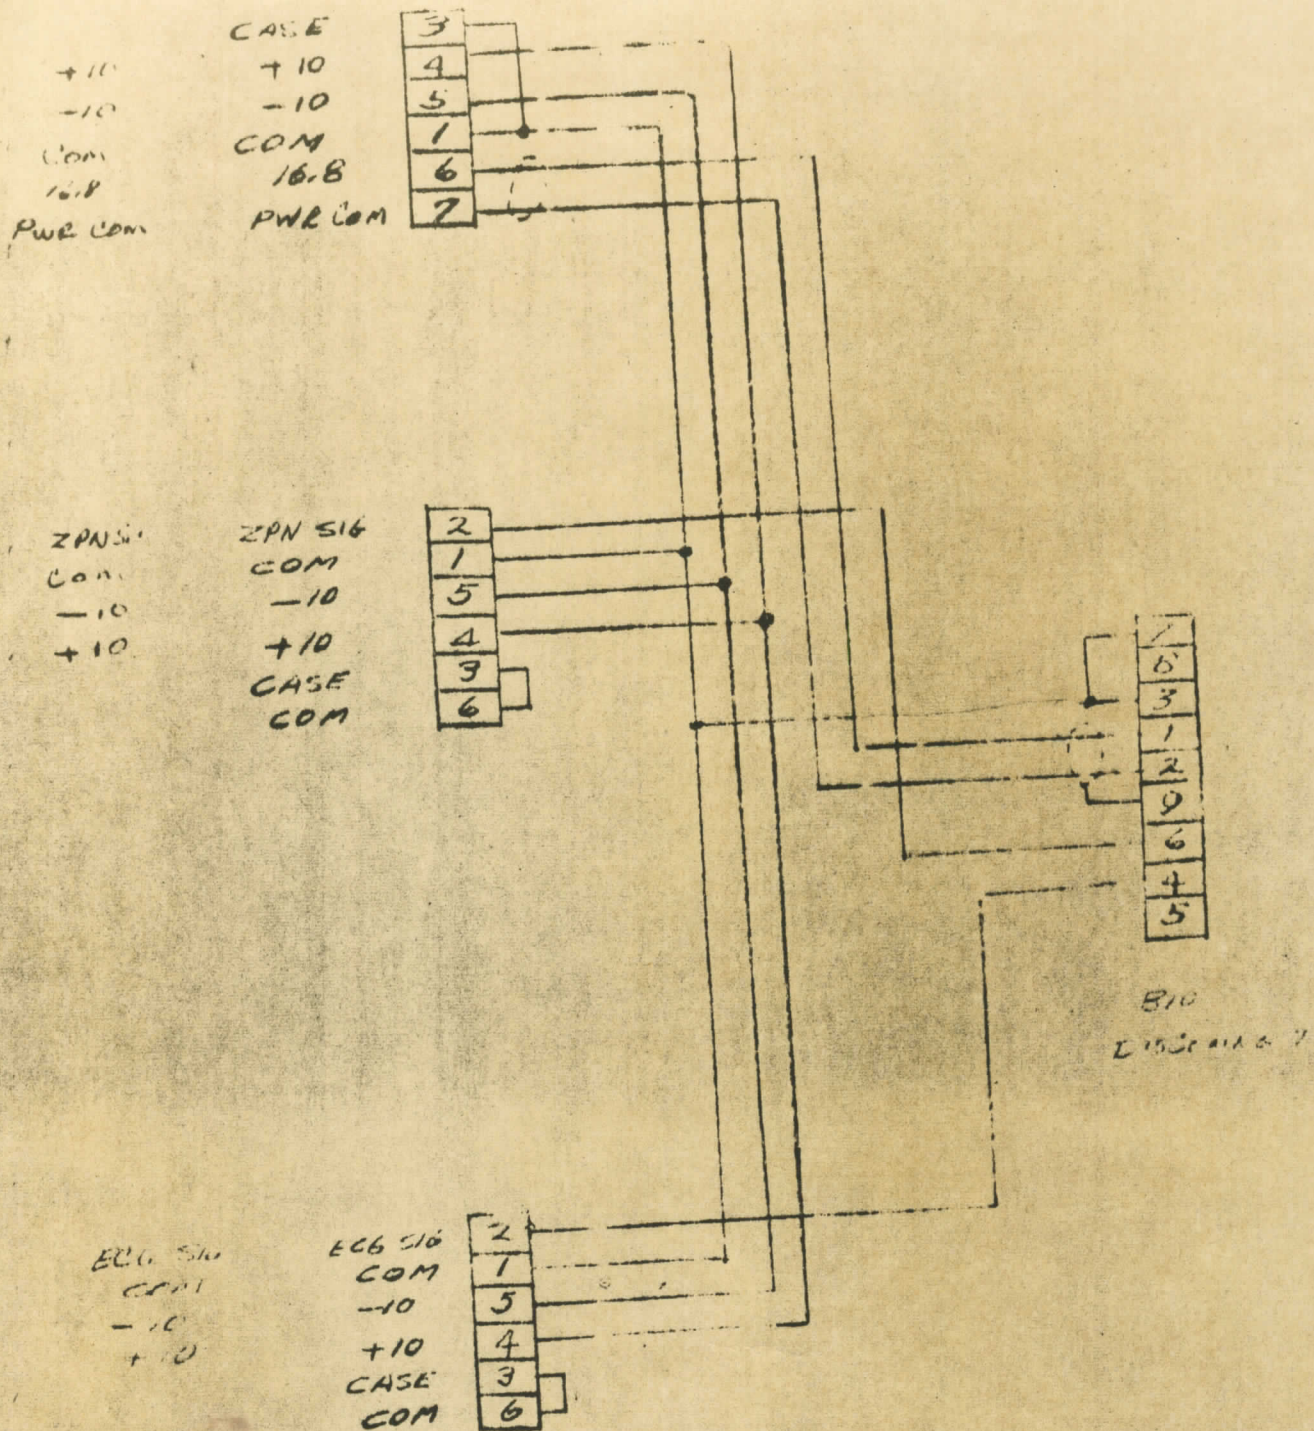
Proposed

First the shock could only be caused by two separate malfunctions of the cable harness. Both of these malfunctions were evident in the cable. They were (1) the shield on the power lead was broken open and (2) the "hot" lead of the power was shorted to the shield past the opening on the "astronaut" side. As Block II bioharness is presently wired this shield lead is common throughout the system and terminates on the astronaut through the biomed electrode. When conditions exist such as described above, the bioinstrumentation is inoperative and allowing a potential of +28 VDC to be applied to the chest cavity of the astronaut. When this occurs, any time he touches ground potential he will feel a shock. This shock hazard exists any time the Block II bioinstrumentation harness, GFE, is used, but the likelihood of it occurring again are quite remote.

The shock hazard can be removed completely by adopting the "proposed" schematic. This will allow the astronaut's body to be at signal ground rather than shield ground. The "proposed" schematic is almost identical to the Block I with the exception that it will allow the use of Block II signal conditions and it will interface with the ILC suit furnished Block II torso harness.

Attention is made that the above change be incorporated into Block II harnesses. A proposed CCA is being prepared for the Apollo Support Branch Configuration Control Board.
