ACTION: Repair of Single Board Drive

Ref: NASA Contract NAS 918230, Item 8

Reference: Item 5 (Prototype Ergometer), Contract NAS 9-18230

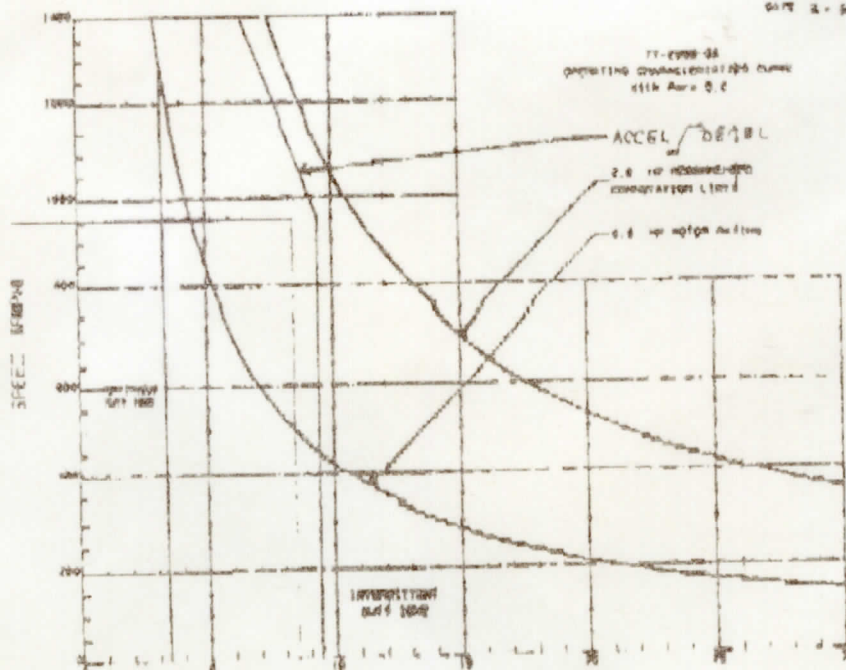
100 lbs = 2.33
0.1" radius TORQUE (LB FT)
= 11.3 lbs
in force
characteristics

There are two operational concerns with the current prototype configuration which should be discussed. The first is the inability of the servo motor and drive amplifier to maintain the required torque to work effectively above a sustained weight of 30 pounds. The second concern is the excessive amount of radiated electro-magnetic emissions from the servo amplifier and motor which renders the device inoperative if fully assembled.

The servo motor and drive amplifier were supplied by the contractor. These components were purchased from the Industrial Drive Division of Kollmorgen as a complementary set and the specifications data assumes both components as a single system. The ratio between the rope drum/sprocket diameter and motor drive socket diameter were chosen so that the ergometer speed and torque requirements fit optimally within the servo motor system operating envelope. Our operational testing demonstrates the servo motor system does not provide the torque indicated by its data sheets. A copy of the torque-speed curves for the servo system is attached to this letter. On this graph, I have penciled in the operating envelope requirement for the ergometer. It should be noted that all other ergometer components will meet these requirements. The recommended resolution of this deficiency is to replace the contractor supplied assemblies with equipment capable of supporting the requirements in high duty cycle operations.
