ACTION: Repair of Single Board Drive

Ref: NASA Contract NAS 918230, Item 8

Reference: Item 5 (Prototype Ergometer), Contract NAS 9-18230

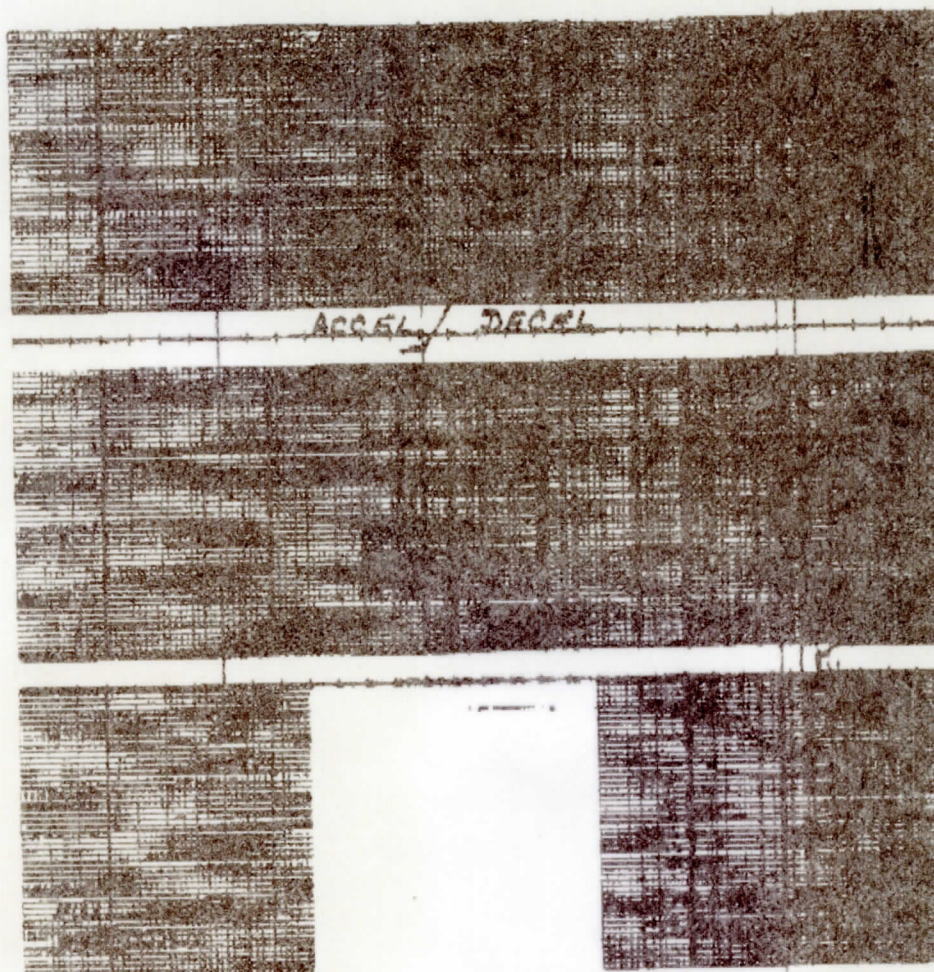
Industrial Drive Single Board Amplifier
Repair: S/N 7C-401

When we received this GFE it was inoperable, as mentioned in the April 16, 1990 status report. At our expense we had one of the circuit boards repaired at a cost of \$318.50. In spite of this repair the GFE will not perform within the manufacturers' specifications.

We have talked with the manufacturer of this GFE and they recommend to replace the circuit boards with upgraded boards and power supply. They say that this upgrade will double the power output. By doubling the output the current 50 pound's force should more than double increase to 100 pound force meeting this specification requirement of 100 pounds.
